**PRESERVATION AND URBAN RELIGIOUS INSTITUTIONS:  
OPPORTUNITIES AND STRATEGIES FOR THE PRESERVATION OF THE  
NINETEENTH STREET BAPTIST CHURCH**

Molly Anne Sheehan

A THESIS

Historic Preservation

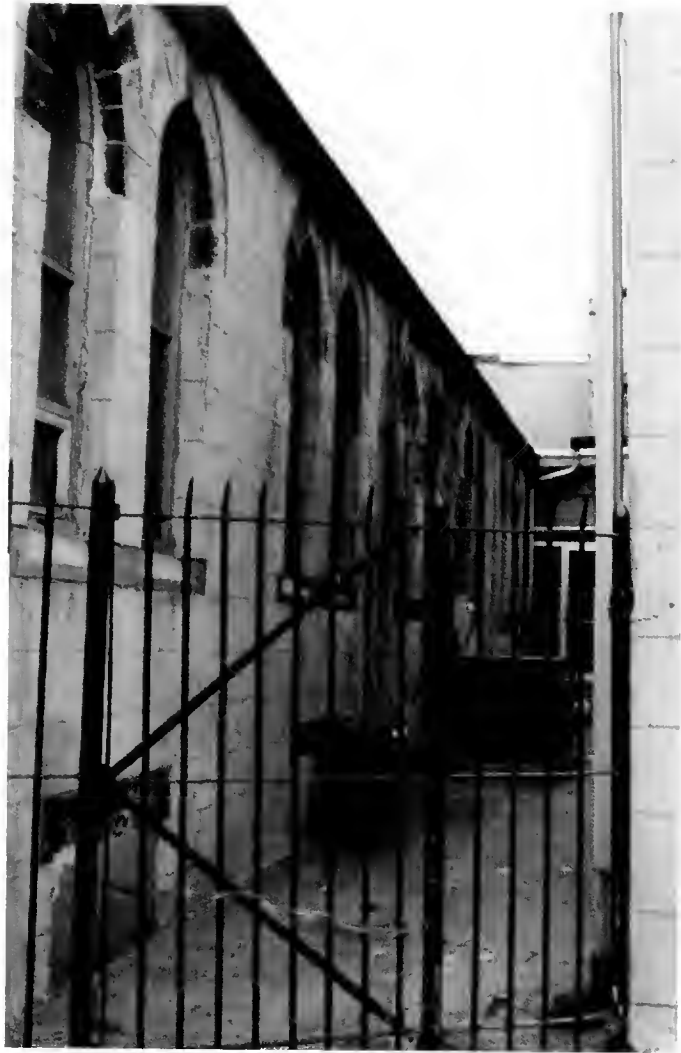
South Elevation of Church Building (S)

<b>Windows</b>
Number: 13 (basement openings have been filled)
Condition: Good
Notes: These window types and conditions are consistent with those noted on other elevations of the church building (stained glass with protective exterior storms). (refer to photograph T)
<b>Masonry</b>
Type: Stucco
Condition: Poor
Notes: The stucco on this elevation exhibits the same conditions noted elsewhere on the church building (cracks, disaggregation, loss of bond to substrate, water damage, staining and bio-growth). The stucco application does not appear to be as smooth as that which was observed on the west and north elevations of the church building. (refer to photographs S, T and U)
Type: Serpentine
Condition: Poor
Notes: Condition of serpentine on this elevation is consistent with that noted for the other elevations of the church building. (refer to photograph U)
Type: Limestone (brown/tan)
Condition: Good
Notes: There appears to be a tan limestone horizontal band two feet from the foundation not noticed elsewhere on the church building. The same staining and painted conditions observed on this elevation is similar to that noted on the other elevations of the church building. The mortar between the limestone units seems to be in better condition on this elevation as oppose to the other three elevations of the church building. (refer to photograph S)
